Short Guide : Maintaining Your Historic Building

THE HONG KONG INSTITUTE OF
SURVEYORS

Funded by Built Heritage Conservation Fund, Development Bureau

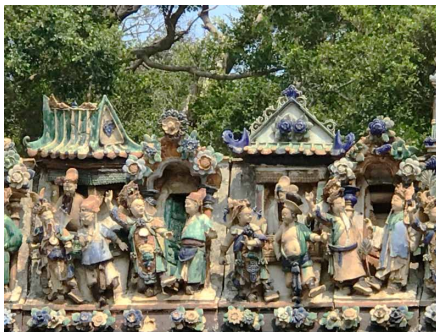
Glazed Shiwan pottery figures at the ridge of Tai O Kwan Tai Temple: exhibiting the story of Song Taizu, Zhao Kuangyin (宋太祖三下南唐)

have glazed roof tiles and decorated ridges with glazed Shiwan pottery figures. The figures exhibit the stages of Xiqu, telling us the stories of the Xiqu.

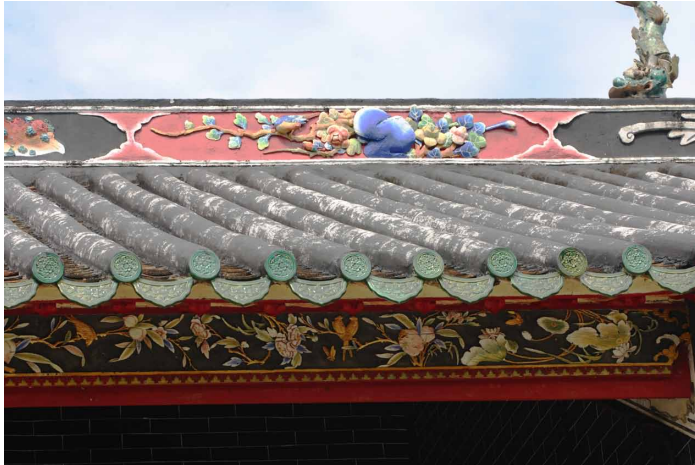
Cap tiles and drip tiles at the eave of the roof

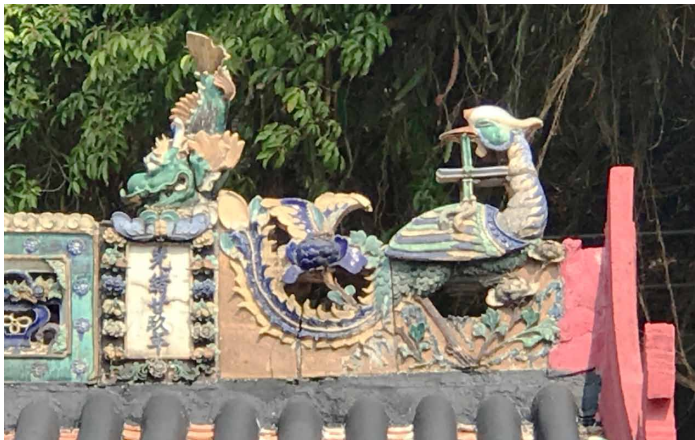
Symbolic decorative features

Left: Dragon fish has the symbolic meaning of suppressing fire; Right: Phoenix has the symbolic meaning of virtue and propriety

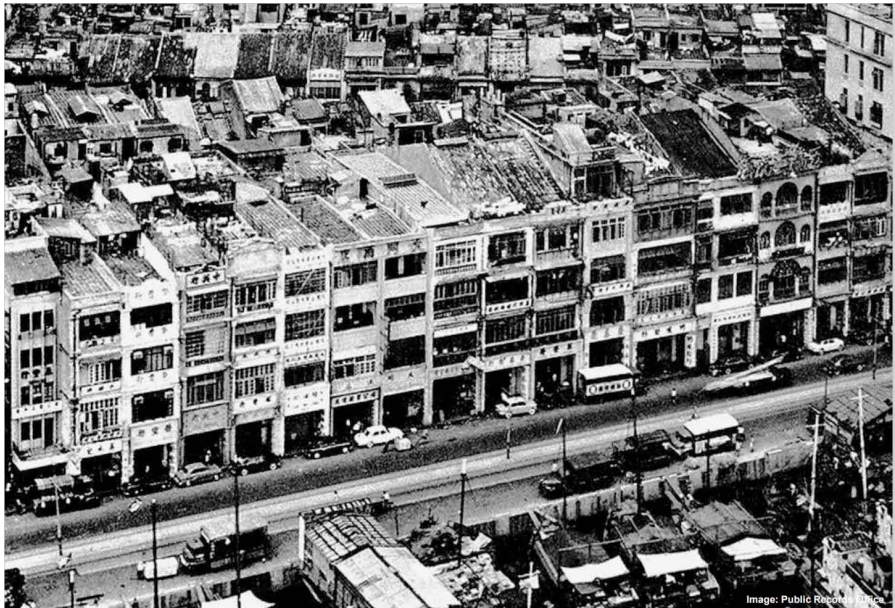
Photo of Sheung Wan in early 20th century showing different-generations of Tong Lau. The top part of the photo shows large groups of Tong Lau without back lanes.

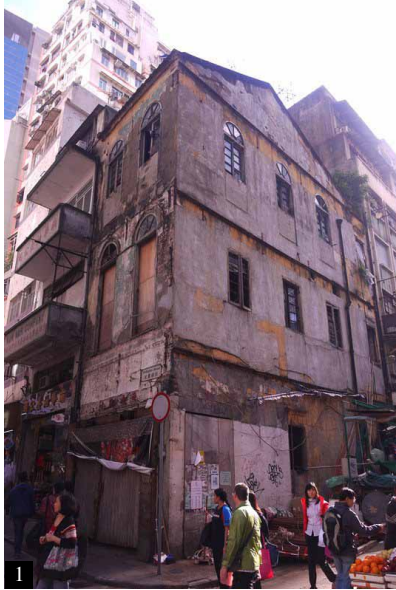
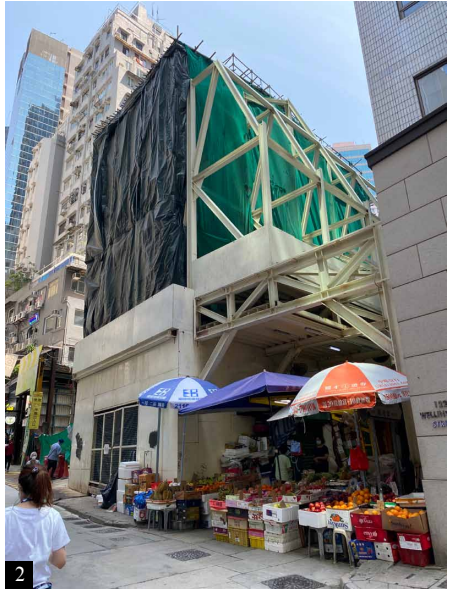
1: The tong lau at 120 Wellington Street was completed in 1884 which housed the famous Wing Woo Grocery. The use of timber floor slabs and beams is very common in this generation of tong lau. This tong lau was once nearly to be demolished (Source: Urban Renewal Authority)

2: The Urban Renewal Authority is currently renovating the structure of tong lau at 120 Wellington Street, Central and promised to reopen it for the public in 2024.

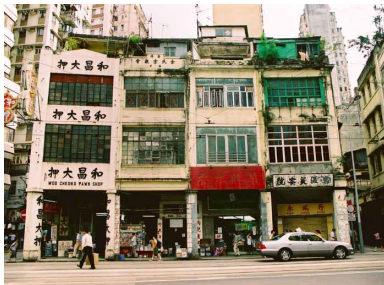
Tong lau with open verandahs in late 19th century at 60-66 Johnston Road, Wanchai. (Source: Urban Renewal Authority)

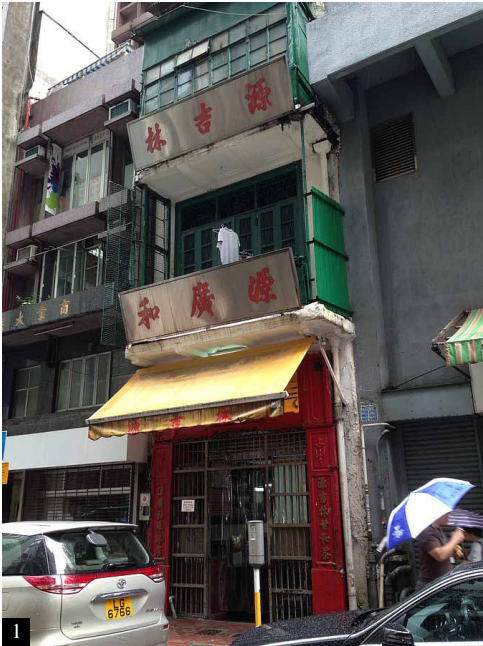
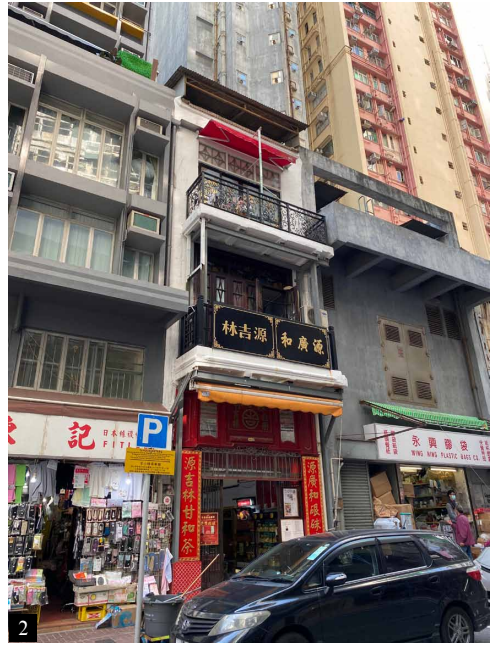
- 1: No 112 Jervois Street, Sheung Wan is the only surviving example of the first generation of tong lau and the fabric and use has not changed much.
- 2: The shophouse at 112 Jervois Street, Sheung Wan was under repair in May 2022.

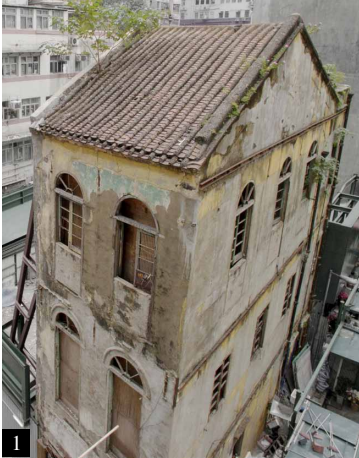
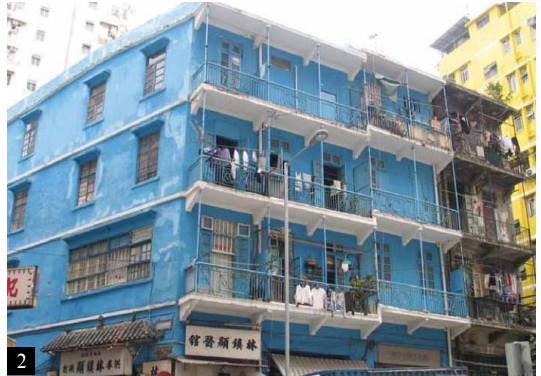
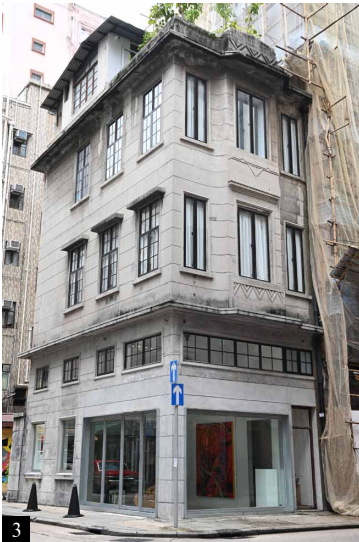
Construction materials and fabric

1. Load-bearing canton green-grey bricks were used. Use of green-grey bricks for buildings of over 36 feet high was not allowed after the Building Ordinance was enacted in 1889.

2. Reinforced concrete, blue-painted brick wall façade and thin concrete balconies which are both functional and decorative were used. Flat roofs and interior timber structure can be found.

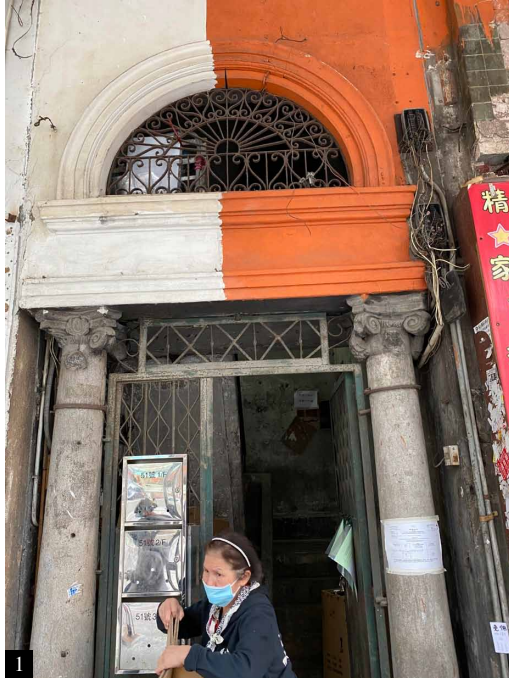
Decorative granite corbel & column

1. The staircase entrance has a small porch formed with Ionic columns supporting arched pediment
2. Ionic columns in an enclosed balcony.
3. The decorative column is distinctive

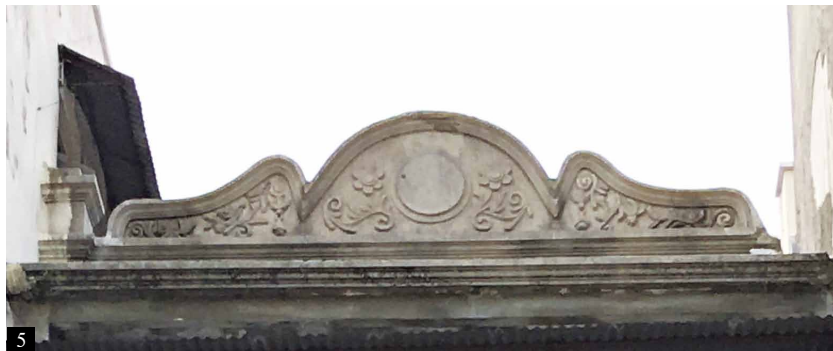
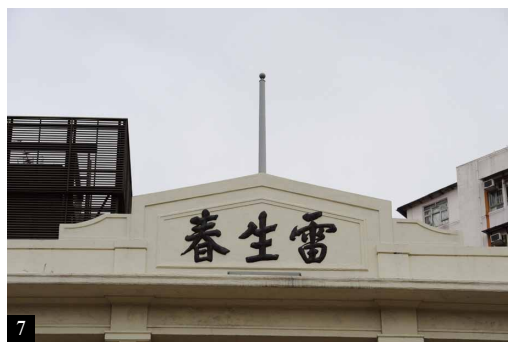
Signage & flagpole

- 5. Traditional sign is found at the shophouse at Nam Kok Road, Kowloon City
- 6. Traditional sign at pediment showing the year of construction is very common at Tong Lau
- 7. Flag pole of Tong Lau

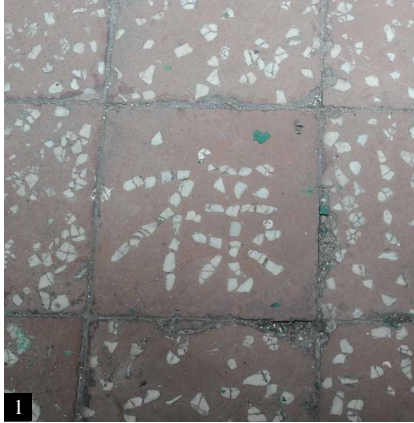
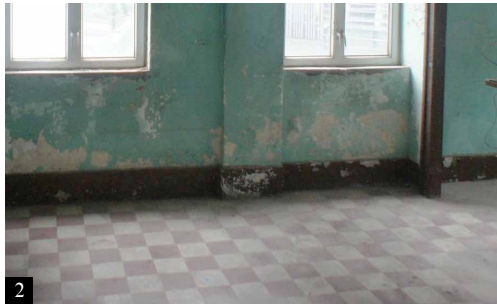
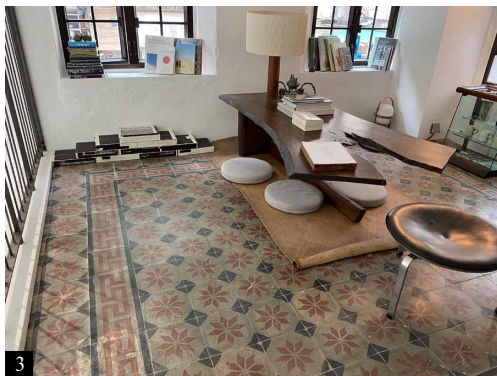
Floor tiles

1. The cement floor tiles with a Chinese character “祿”, which means it will bring wealth to the family
2. There are floor tiles of checkerboard pattern found in the tong lau building at 88-90 Staunton Street, Central
3. By preserving the floor tiles, the authenticity of shophouses can be revealed

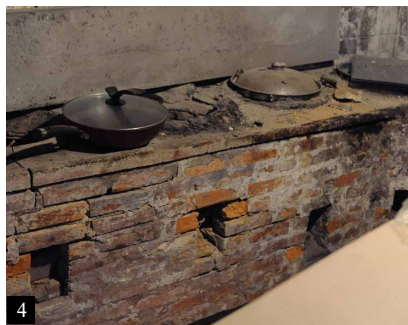
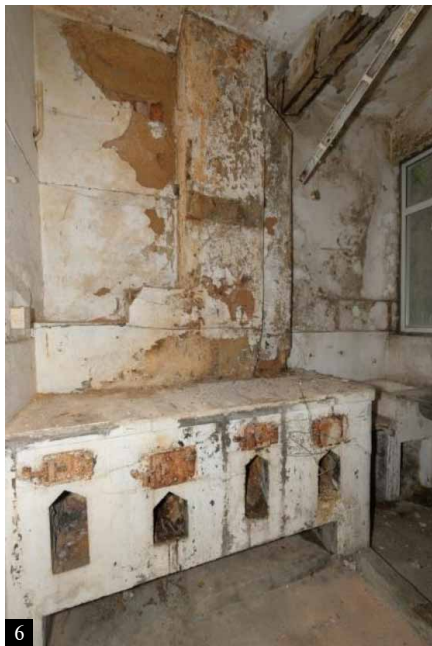
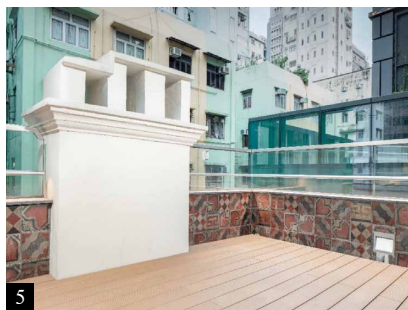
4, 5, 6 Kitchen & chimneys stucks for kitchen

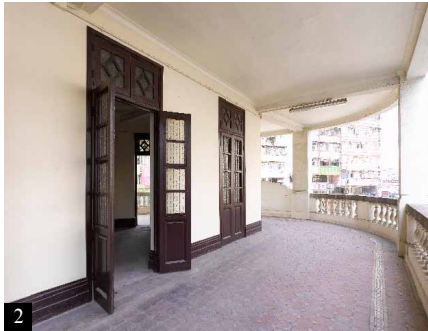
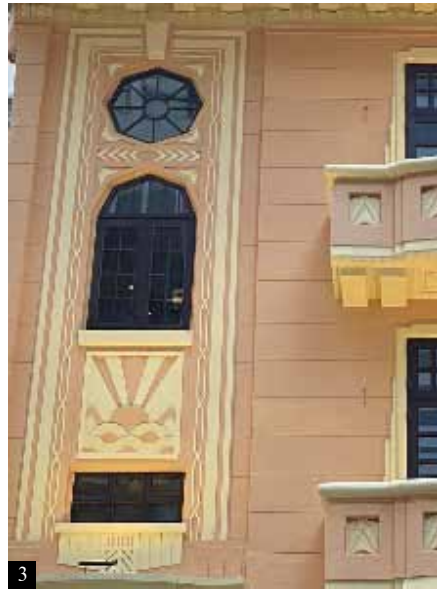
1. Reminiscent of Chinese Manchurian style, windows with exquisite design of lozenge patterns were fitted with pressed glass of different colors
2. The use of French windows is very common in some tong lau building
3. Geometrically shaped windows are used. Octagonal windows are meant to keep evil spirits out of the home.

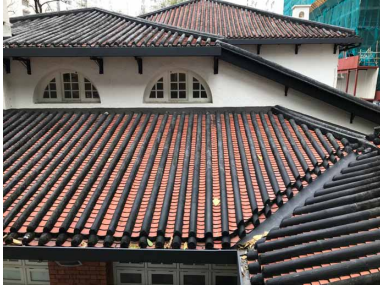
Double tiles double rolls is commonly found in Western historic buildings

is constructed with clay tiles in the form of roll tiles, pan tiles and sometimes with some decorative tiles at the eave. The most common types of roof covering are as follows:

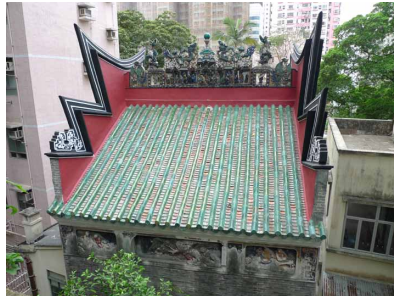
Double tiles single roll is commonly found in Chinese vernacular architecture such as ancestral halls and residential houses

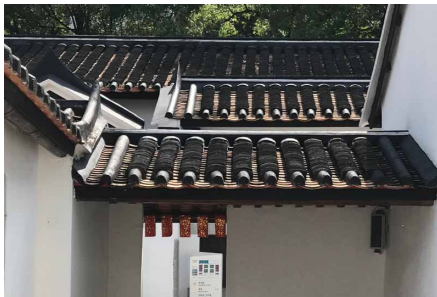
Hakka roof covering is commonly found in village houses

For Hakka roofs, debris like soil or leaves will be trapped in the tiles. This will affect the flow of the water down the sloping roof. If the situation gets worse, water will soak and saturate the tiles, and then water may drip down into the internal area. Traditionally, the occupants would climb up to the roof annually to clear away the debris, replace broken tiles and pack up the tiles after the harvest season. Nowadays, owners are not encouraged to do the work by themselves due to site safety. Depending on the extent of debris accumulation, they shall appoint specialists with adequate site safety measures to carry out the work annually or biannually.

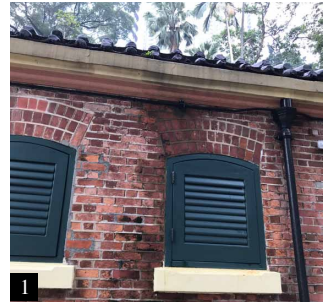
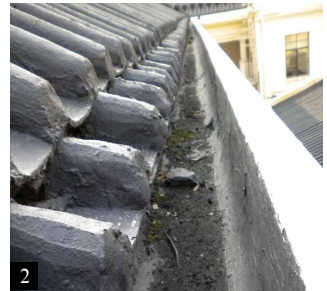
1. Damp patches indicating failure of roof gutter
2. The drain hole connected to the downpipe was blocked causing water to flow back into the internal side.
3. Leaves and debris are trapped on the roof surface, which affects water flowing down the roof. The trapped water will saturate the tiles and cause water leakage.

Water penetration from the slope of the roof is rare since the roof design is effective for disposal of rain water. Rainwater disposal, however, will be affected by blocked roof gutters or downpipes. It is one of the major causes of dampness in masonry walls of Western historical buildings with roof gutters and downpipes. This problem is less found in Chinese architecture as there is usually no roof gutter at the eave. If there is a parapet wall higher than the eave in front, the situation will be even worse. As the water cannot be disposed quickly, it will overflow underneath the tiles and wet the head of the masonry wall, causing damage to internal finishes. In the worst scenario, continuous moisture will cause rotting or termite infestation of the timber wall piece resting on the wall head. Subsequently it will affect the timber trusses or rafters resting on the wall piece, resulting in structural failure of the roof structure. If damp patches are found on the upper part of a masonry wall, it may be an indication of a blocked roof gutter or failure of waterproofing of the precast roof gutters.

Regular inspection and clearance of the debris and blockage on roof gutters is necessary. Most of the roof gutters are at a high altitude. The work should be carried out by workers with safety precautions. To prevent blockage of the gutter by leaves, there is a trend to use gutter brushes in the gutters, but

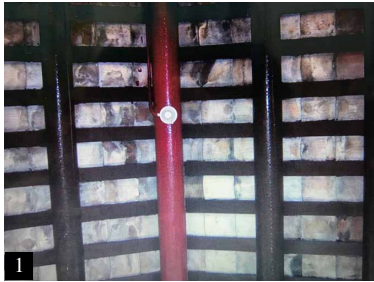
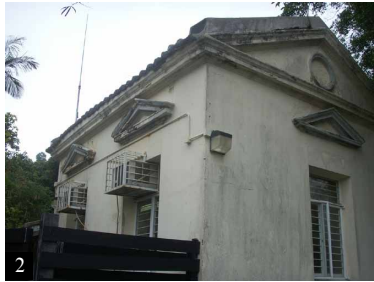
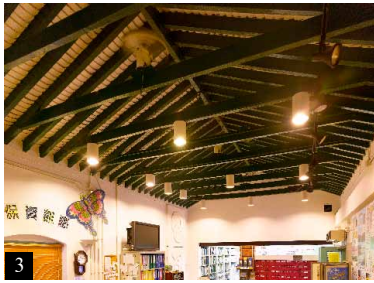
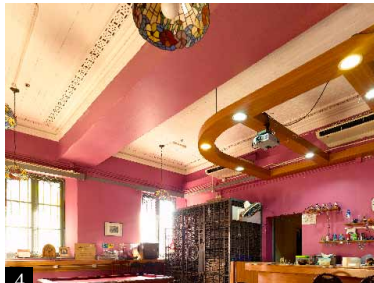
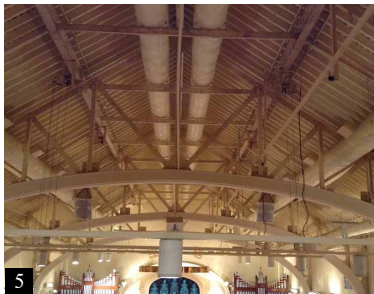
1. Water drips onto the purlins due to condensation
2. Openings at gable ends were blocked. They shall be opened for providing cross ventilation by means of fixing weather-proof louvre to the openings
3. Oscillating fans at truss to create air circulation at roof space
4. Mechanical ventilation system to vent the roof space
5. Fretted boards as border at ceiling panel for ventilation and as decorative features

Historic buildings were designed with proper consideration of ventilation by employing ridge vents, louvre openings at the gable end, etc. These vents and openings provide cross ventilation to the humid void space in a natural way to prevent condensation and rotting of the timber structure. However, to achieve thermal comfort, many historical buildings are equipped with air conditioning. The vent and opening were blocked. The hot and moist air will condense on the roof soffit of the room with air conditioning. Therefore, water drops are visible on the purlins. This is always mistaken as rain water penetration from the roof and induces unnecessary or improper repairs to the roof covering. Maintaining cross ventilation and preventing moist air from stagnant in the triangular void underneath the roof can effectively prevent condensation. A simple remedial approach is to restore the original design by opening the

roof vent or louvre openings. Installation of oscillating fans or mechanical ventilation at the void is another approach to prevent stagnant moist air and drawing away the humid air from the void. If there are ceiling panels in the room, provision of openings at the ceiling panels can improve the cross ventilation. Traditionally, the fretted board was fixed on the ceiling for ventilation and as a feature of decoration.

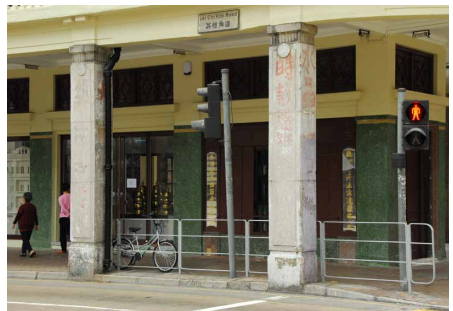
Stone column of tong lau

Local residents also used stone to construct their houses. Large stone pieces are too expensive to them. Instead, they used smaller pieces of stones and rubbles to construct their houses. Stone House at Kowloon City is a typical example of rubble wall house. Some Chinese houses and tong lau were also constructed with stone at the front façade or as columns to show their significance.

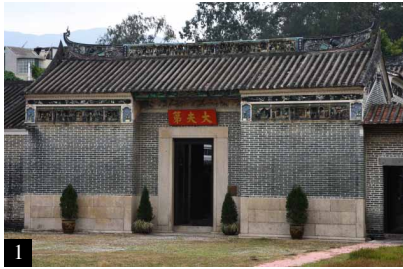
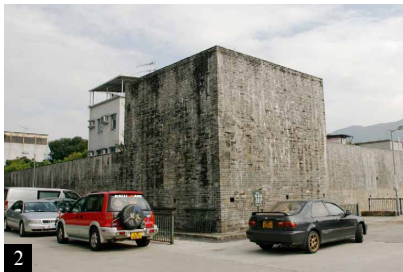
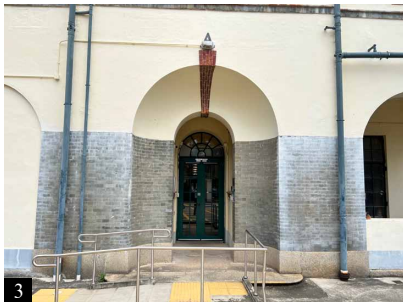
1. Grey brick wall of Tai Fu Tai Mansion at San Tin
2. Grey brick wall of Kun Lung Wai, Fanling
3. Grey brick wall at Kowloon Hospital
4. Typical construction of a Chinese grey brick wall. Two leaves of stretcher bonds (shun 順) with a cavity between them, the two leaves are tied by a course of header (ding 丁) at regular interval. Common brick bonding patterns include three shun one ding (三順一丁) and five shun one ding (五順一丁).

and with better alkali resistance and durability. These grey bricks can be found as facing bricks in Chinese traditional buildings like ancestral halls, study halls, walled villages and some village houses in Hong Kong. High quality grey bricks were also used in Western historic architecture. The fair face grey brick wall with hairline pointing at Kowloon Hospital is one of the best examples.

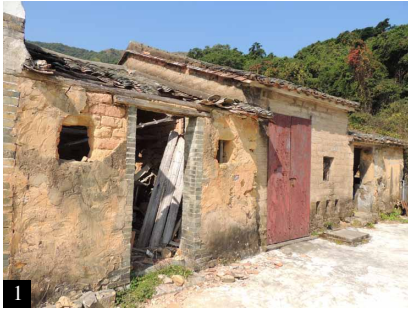
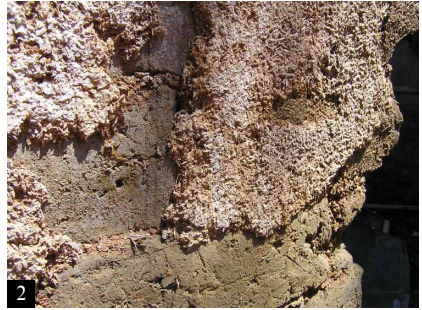
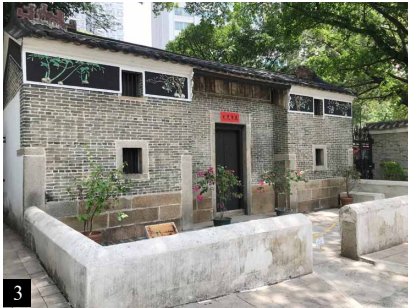
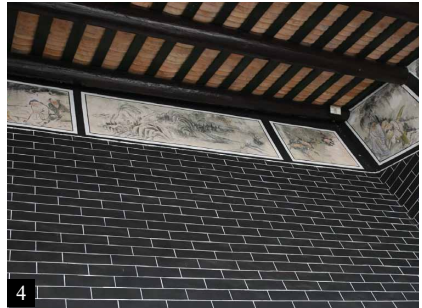
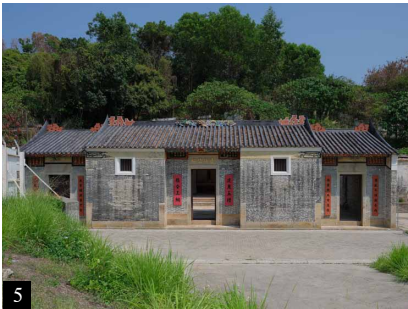
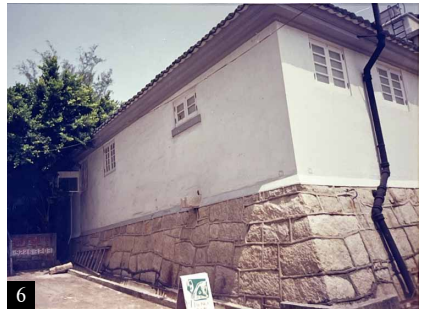
1. Mud brick house
2. Lime render of mud brick wall with shells of crops added
3. Elegant front façade with granite stone footing and fair face brickworks. Internal walls and side walls were constructed with mud bricks
4. Wu yin lime render with drawn brick lines
5. Tat Tak Communal Hall at Ping Shan, Yuen Long
The plinth of the wall normally constructed with rubble stones to reduce rising damp
6. Old Stanley Police Station at Stanley

The earthen mortar is made from lime earth with addition of different materials like grain shells, straw, grass, etc. Some limewash render mixed with Wu Yin (black carbon soot) was used to provide a dark grey finish. Thin line was pressed onto the render and brick lines were drawn along the line to imitate a grey brick wall.

Many Chinese historic buildings would compose different types of masonry in one building. For example, for some relatively important Chinese houses like ancestral halls, the plinth of the walls was constructed with granite stones or rubble stones for better control of rising damp. Red sand stones were sometimes used to show that members of the clan had certain official ranking in the Qing Dynasty. For some village houses, stones and fair face grey bricks can be found at the most important front façade, while side walls or internal partitions were constructed with mud bricks or rammed earth to save the cost.

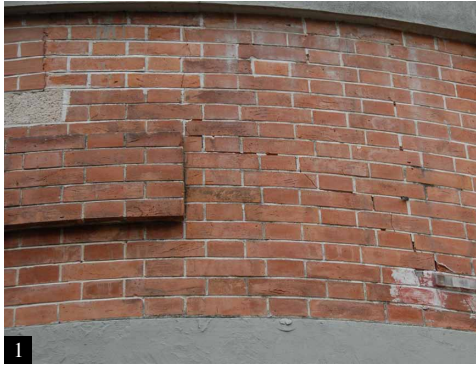
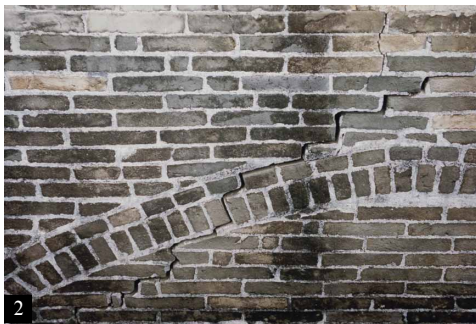
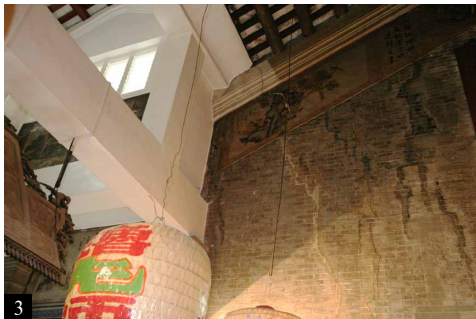
1. Diagonal cracks along the pointing of a brick wall. A tell-tale (small piece of glass plate) was found at the bottom right corner to monitor the progress of the crack.

If the cracks were caused by application of strong pointing mortar, repointing with lime mortar matching the profile of the original shall be carried out. The mortar shall be softer (measured in compressive strength) than the bricks or stones. Pigment might be added to the mortar to resemble the original.

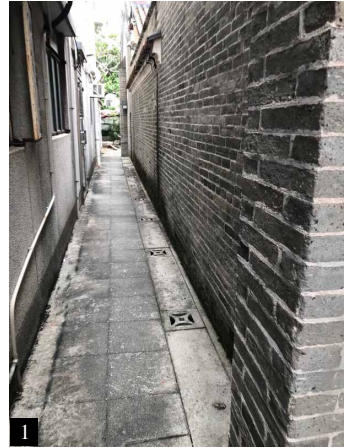
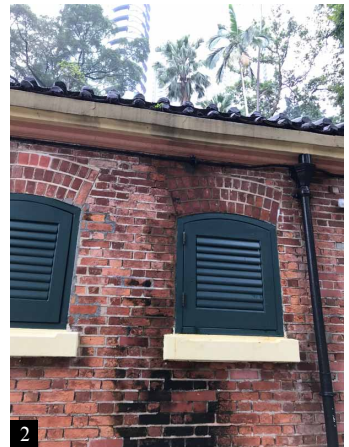
1. The dark stain at the lower part of the wall is caused by the growth of algae. It is an indication of a damp wall. The moisture may be caused by rising damp or water splashing from the hard paving surface.

Rain penetration through walls can be the result of cracks in the render of earthen walls, water absorption of the masonry wall itself or defective pointing. Water penetration in brick or stone walls may not have significant problems if the moisture is allowed to evaporate from the wall before it is saturated with moisture. However, if the wall was finished with impermeable plaster or finishes, or cement base pointing is being used to replace the traditional lime based pointing, the rate of evaporation will greatly reduce and the wall will become saturated and cause problems.

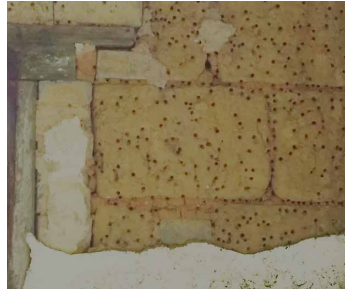
Pitting on mud bricks by insects will increase the risk of water penetration.

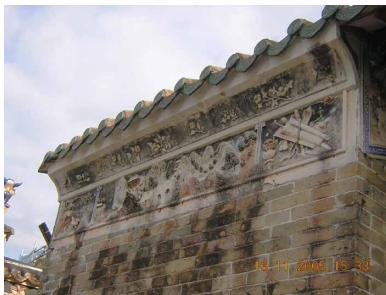
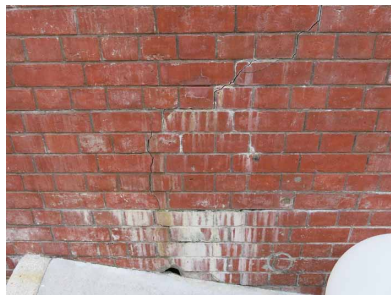
Running water stains can be reduced if water drip lines or grooves are formed at the upper frame of the plaster decoration.

1. Brick spalling on some of the bricks
2. Running water stains can be reduced if water drip lines or grooves are formed at the upper frame of the plaster decoration.
3. Erosion of red sandstone due to weathering

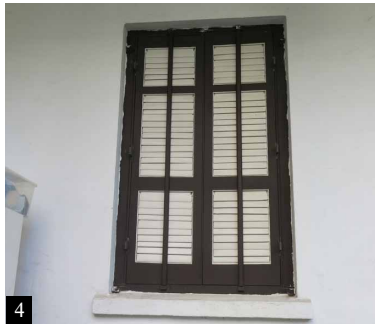
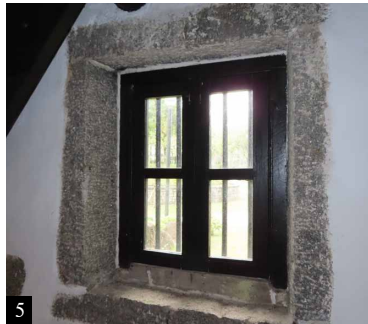
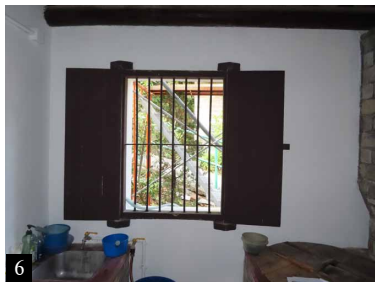
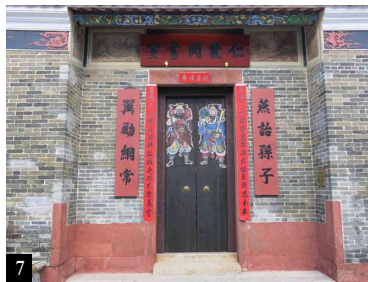
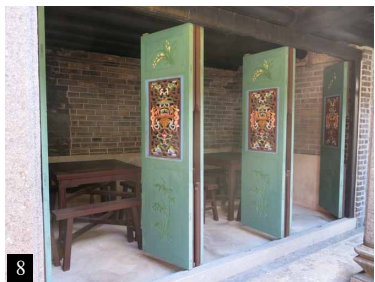
4. Timber window shutters
5. Timber flush windows in traditional Chinese architecture
6. Timber panel windows in traditional Chinese architecture
7. Timber flush doors in traditional Chinese architecture
8. Timber panel doors in traditional Chinese architecture
9. Crafted timber screen doors in traditional Chinese architecture

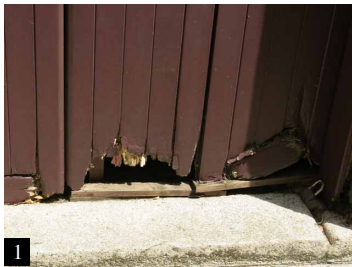
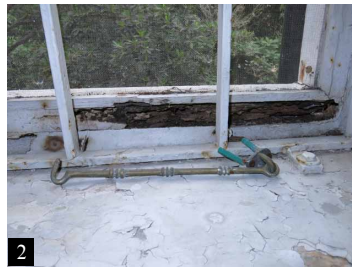
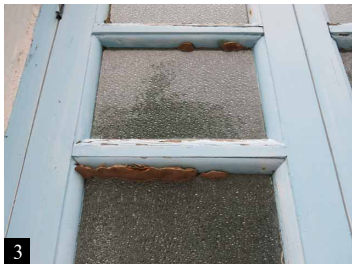
1. Wet Rot
2. Wet Rot
3. Dry Rot

Wet rot is usually found in damp environment where water accumulates and remains within the wood, e.g. the bottom rails of door / window leaves.

Dry rot is usually found in environment of low moisture content. In addition to the decay of timber, a “fruiting body” of fungus is sometimes found on the infected timber elements.

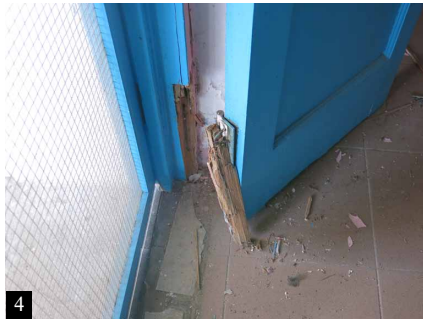
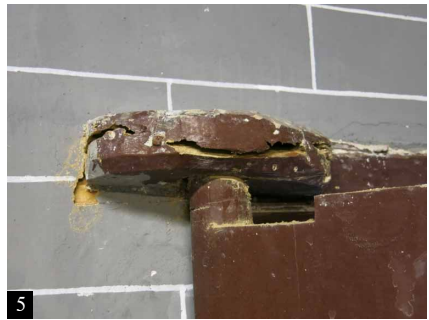
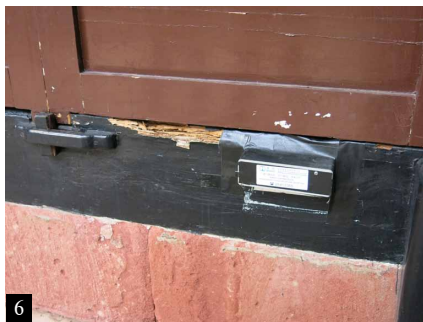
- 4. Termite attack on door jamb
- 5. Termite attack on door hinge
- 6. Termite attack on screen doors

Specialists should be appointed to carry out disinfestation treatment and skilled carpenters should be appointed for repairing works of traditional timber elements.

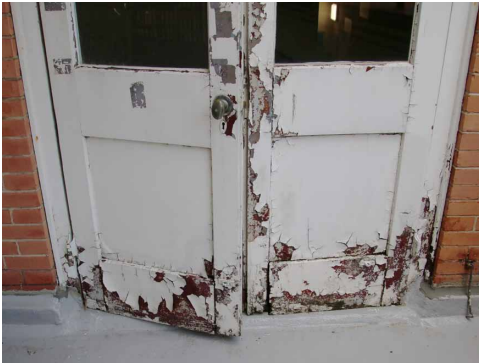
Flaking paint on timber doors

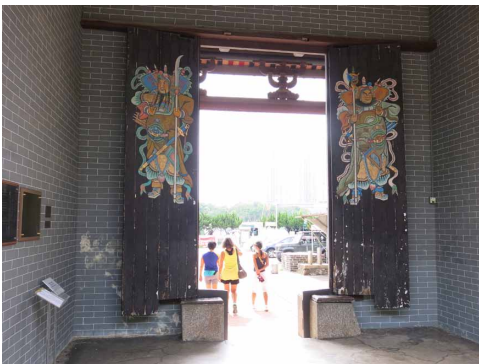
Faded out door gods painting

In addition, being one of the character-defining elements often found in Chinese architecture, the door gods painting at the entrance of temples and ancestral halls should be repainted from time to time.

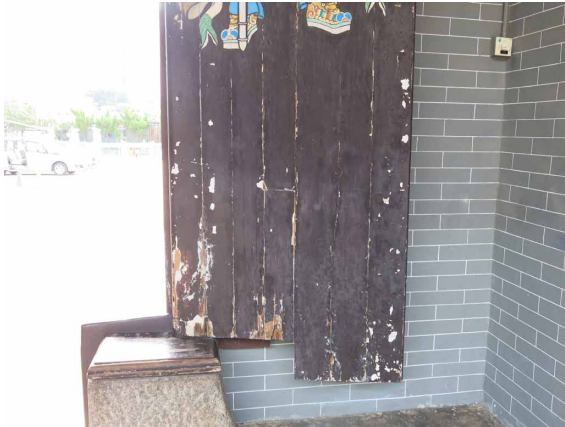
Frequent operation of doors / windows may result in minor defects such as worn off paintwork, chipped timber frame / panel, failure / loosening of ironmongeries, etc.

Wear and tear on timber door

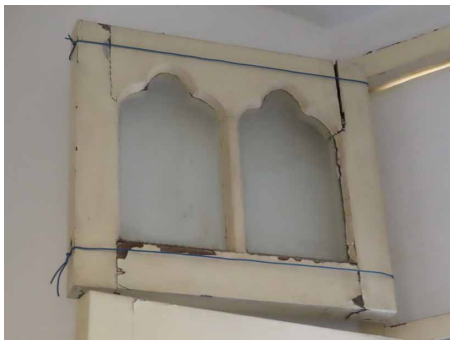
Dislodged timber frame on top vent

Deformation / dislodgement may occur as a result of structural movement of the building or thermal movement of the timber components. The timber door / windows should be rectified at once if it poses any risk such as disintegration of or falling off of the window sash due to the deformation / dislodgement.

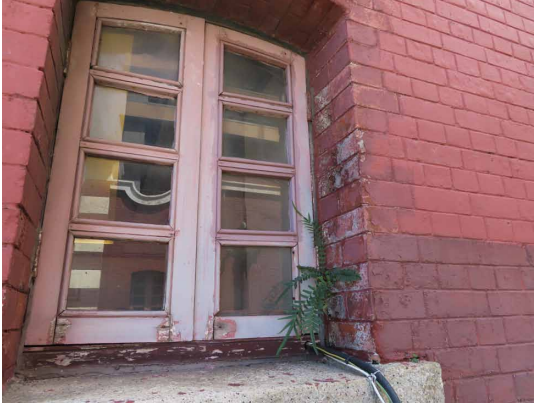
Vegetation growth is often noted near windows in the presence of fissures and accumulation of water around the window sill. The plant roots may threaten timber windows and lead to water seepage to the interior of the building.

Vegetation growth on window sill

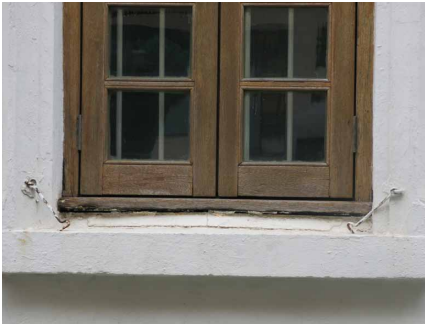
Gaps at window surround

Gaps between the door / window frame and the wall opening due to rotting / thermal movement of the timber frame or loss of grouting between the frame and wall opening could lead to water ingress to the interior of the building.

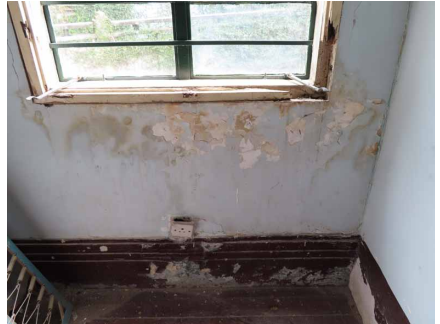
Water seepage at window surround

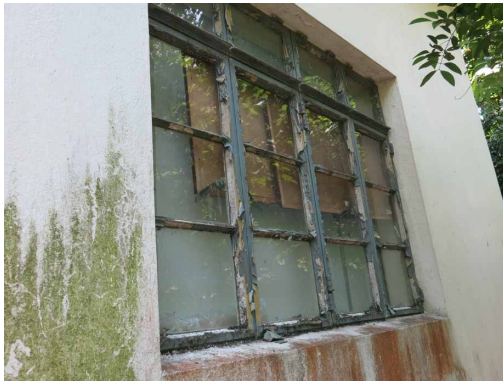
Painting on ferrous metal doors / window frames can protect metal components from oxidation and thus corrosion. However, it is normal for the paint coats to deteriorate and start flaking in a few years and repainting is needed as a preventative measure under regular maintenance.

Flaking paint on metal window frame

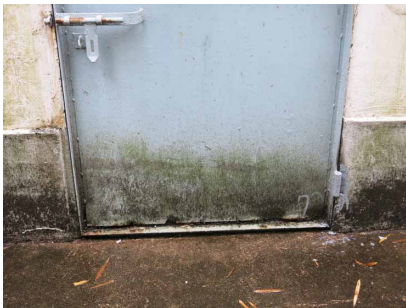
Mould and algae growth

The metal doors / gates exposed to the damp environment are likely to suffer from mould / algae growth.

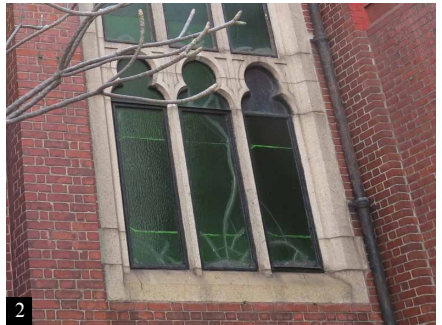
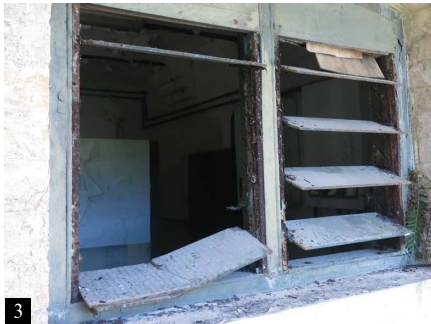
Besides, cracking of the glass panes could also be resulted from frame distortion, e.g. corrosion and expansion of metal window frames.

1. Cracked glass pane
2. Cracked glass panes
3. Broken and missing glass panes on louvres

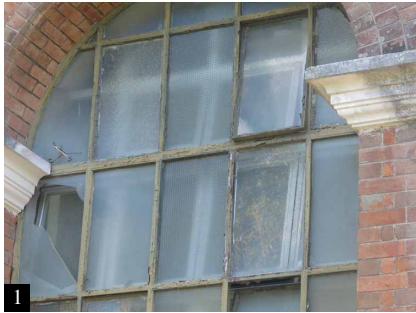
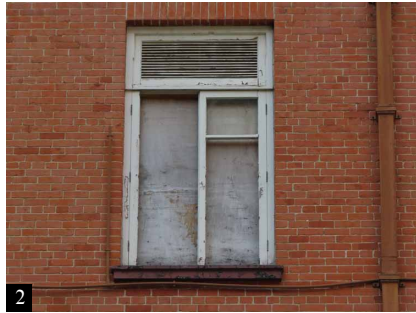
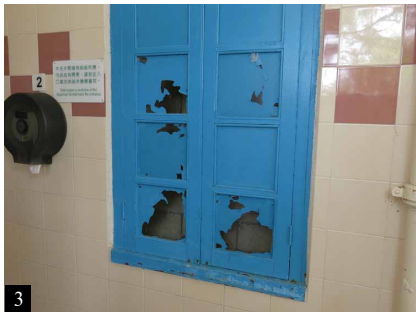
1. Replacement of glass panes with inconsistent textures
2. Windows without glass panes are boarded up
3. Painted over glass panes

Defective windows are sometimes boarded up and prohibited from use instead of being rectified.

When some doors / windows are no longer being used, they may be sealed up or painted over.

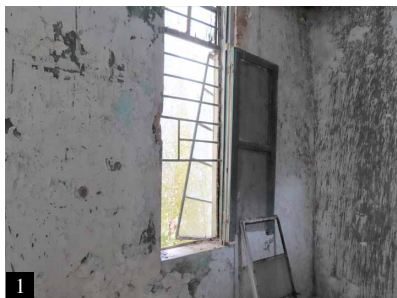
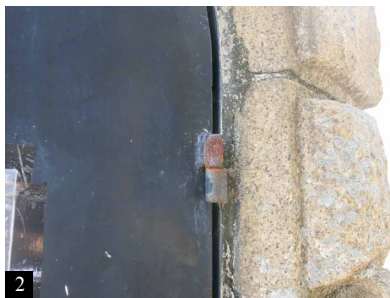
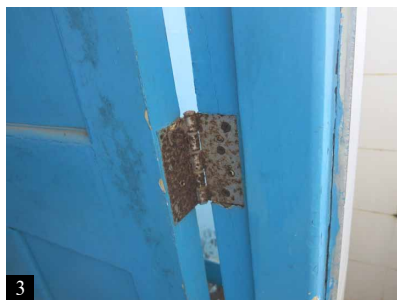
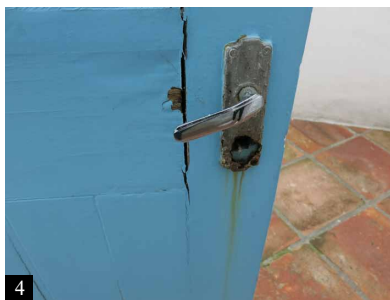
1. Detached window sashes
2. Rusted barrel hinge
3. Corroded butt hinge
4. Missing door lock

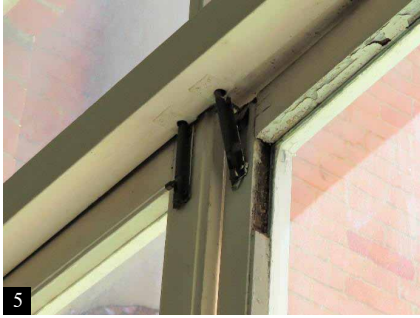
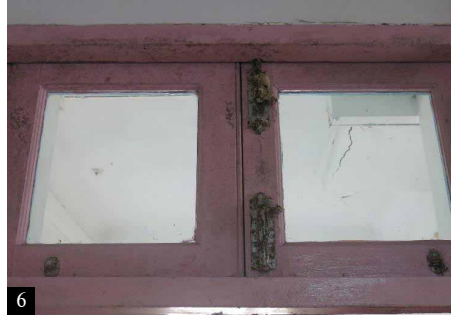
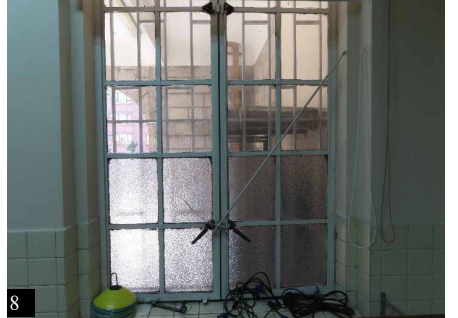
- 5. Detached bolts
- 6. Corroded bolts
- 7. Broken window stay
- 8. Broken tie bar

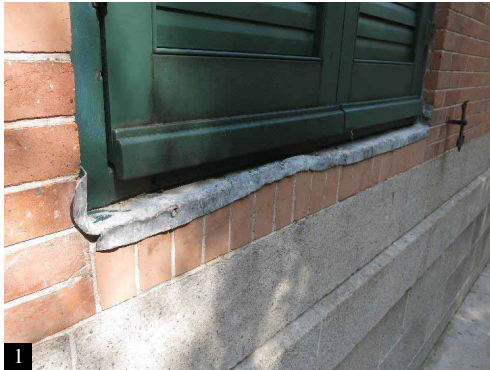
1. Addition of lead flashing for improvement of water-proofing design at window opening
2. Salvaged ironmongery of windows and doors

To consider improvement / enhancement works to mitigate the influence of the existing components with minimal intervention to the original building design.

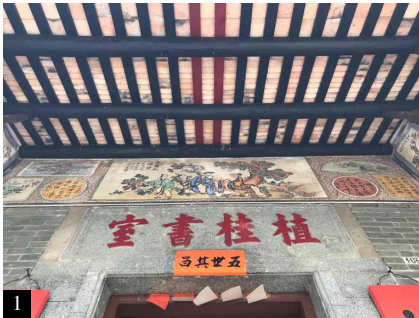
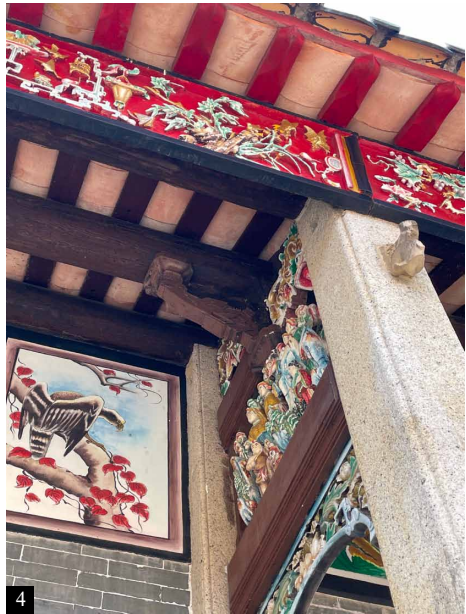
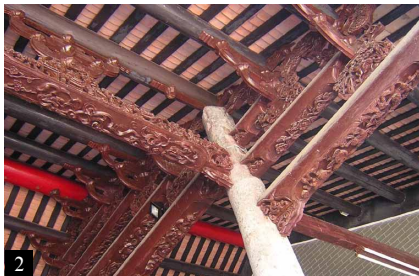
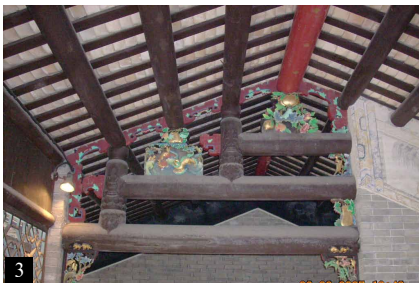
1. Timber purlins and timber battens of roof at Chik Kwai Study Hall at Yuen Long
2. Richly carved timber beam and strut system
3. Tuofeng at Tai Fu Tai Mansion, San Tin
4. Duogong at Yeung Hau Temple, Tai O

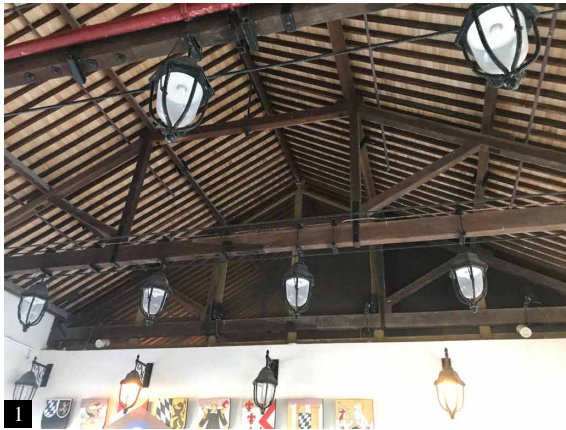
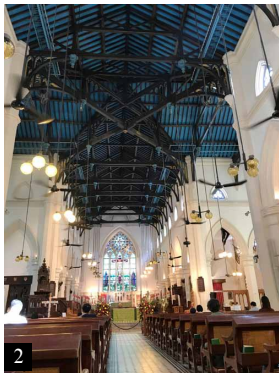
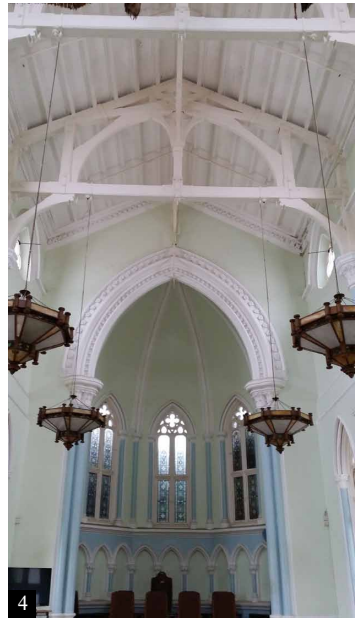
are the king post truss and the queen post truss. For a larger span and high headroom, portal form trusses are used. For example, the St. John's Cathedral, Central, which has a high headroom and long span, has a main portal that was completely rebuilt using timber from a British military ship. The roof of the Chapel (Dining Hall) of the University Hall, the University of Hong Kong is also supported by timber trusses resting on symmetrically placed vaulting shafts.

1. Timber roof truss - Queen Post at Murray House, Stanley
2. Main portal at St. John's Cathedral, Central
3. Timber roof truss - King Post.
4. Timber truss at dining hall of the University Hall

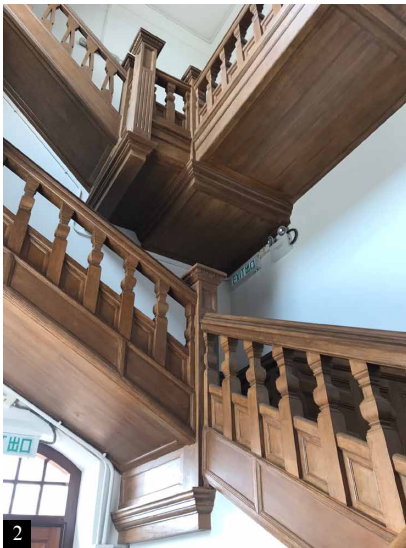
Staircases in Western historic buildings are sometimes made of timber which are supported on timber strings, carriage and cantilever beams. The steps and railing are also constructed with timber. The railings are important decorative features in a Western house.

1. Timber staircase at Tai Kwun, Central
2. Timber staircase at the Clock Tower, Tsim Sha Tsui

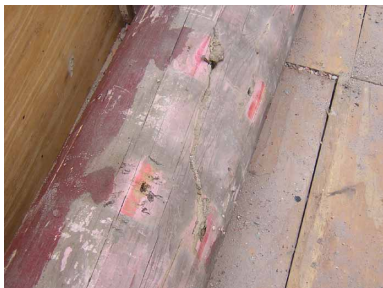
Termite attack is one of the most common defects found in timber due to the hot and humid weather in Hong Kong. Mud tubes or termite trails are common signs of termites. Mud tubes are shelter tubes built by termites to travel to and from the food source, usually appeared as a long brownish-yellow line on the wall or the timber column or beam. Another sign is termite droppings - termites often leave behind brown-coloured faecal pellets after consuming wood. When tapped on timber attacked by termites, they usually sounded hollow.

Mud tube on timber purlin

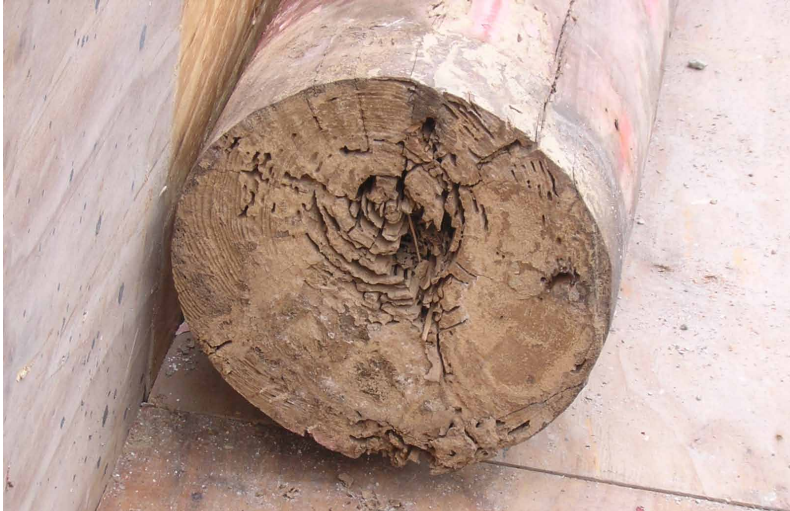
Termites damage timber structural elements by consuming the wood inside. The structural elements such as columns or beams then become hollow and therefore are no longer able to support the structure of the building.

Timber purlin damaged by termites. Termite infestation may be overlooked as the termites sometimes consume the internal sap wood, while the external still looks sound.

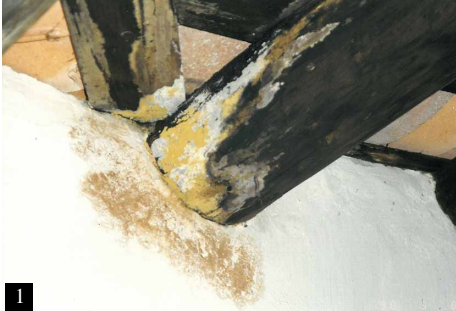
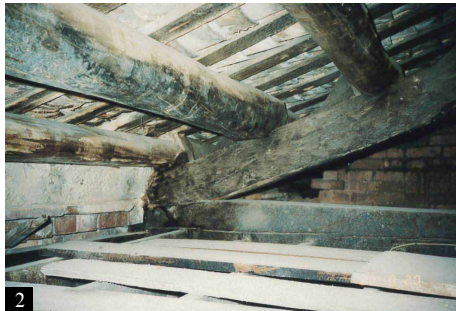
Rotting is caused by the presence of different types of fungi. Favourable conditions for fungal growth include temperature between 24 to 32 °C, presence of moisture, sufficient oxygen and food, such as wood. The weather in Hong Kong is usually humid and hot, which creates favourable conditions for fungal growth. Water leakage from the roof would also increase the risk of rotting as a continuous water source would increase the moisture content of the wood and hence provide favourable conditions for fungal growth. Sometimes, rotting and termite attack might happen at the same time as the timber structure might have spores or cracks which allow fungi or termite infestation. Signs of rotting include hollowed timber structures and badly infested timber.

1. Fungal attack at the end of timber resting on the wet wall
2. Timber decay at the end of a timber truss which was embedded in a damp wall

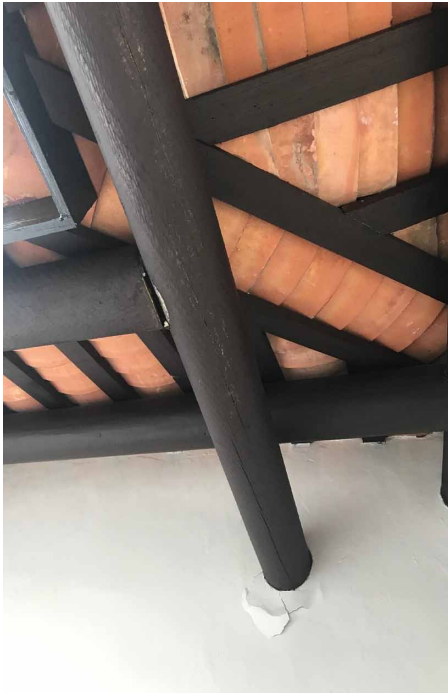
Cracks that require attention to are structural cracks. They are caused by overloading and if left unattended, this could lead to collapse of the whole structure.

Shrinkage cracks on timber beam

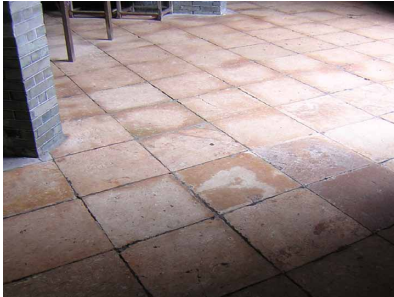
Terra cotta Canton tiles are the most economical of the various hard flooring options mentioned. The fired tile tends to display various shades from brown, red to pink.

Terra cotta Canton tiles paving in a side chamber of a Chinese house

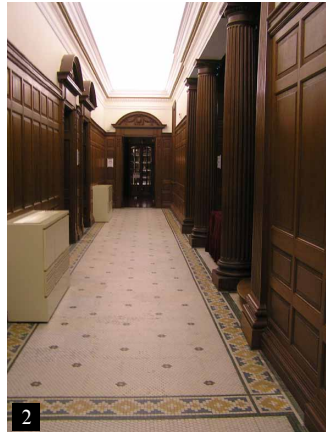
1. Encaustic tiles on the corridor of the Main Building, the University of Hong Kong
2. Mosaic tiles used as flooring at Kom Tong Hall

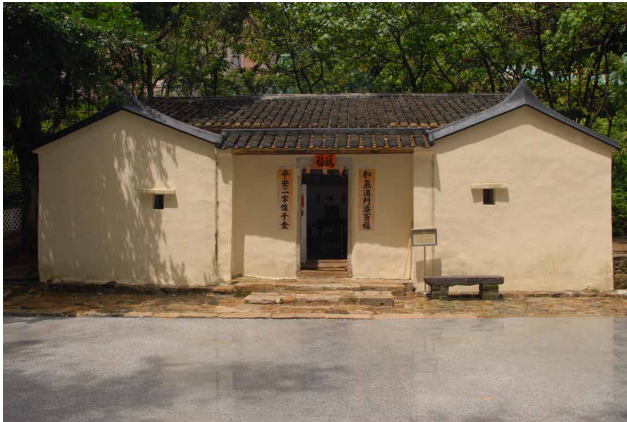
In Hong Kong's hot and humid climate, lime wash—referred to as white liming and whitewash until the mid-1900s—was the most practical of exterior finishes. Lime wash can also be tinted with a range of pigments.

A lime-based whitewash wall.

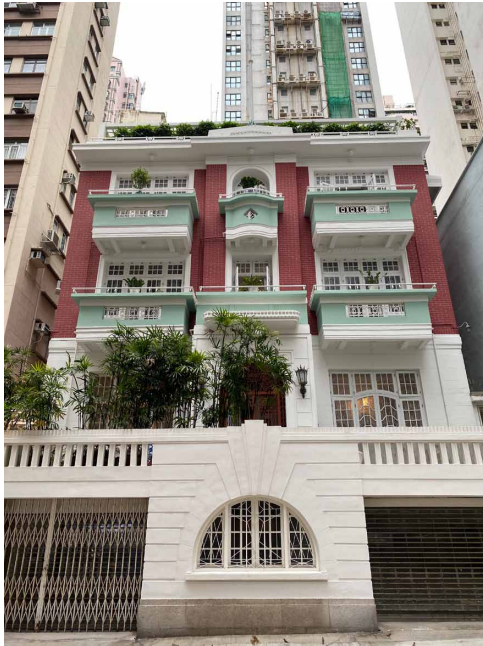
Modern paint includes several types such as distemper, washable distemper, cement paint and modern emulsion paint. The colour of the modern paint varies and is typically affected by a powdered pigment (e.g. earthen ochre or mineral sources). Among these, mineral paint has breathability. Modern emulsion paint became widely used in the postwar years and is now the mainstream of building paint today. However, generally designed for modern cement plasters, synthetic paints are film-forming with low vapour permeability, and thus not suitable to serve as the substrate for lime plaster.

Modern paint used on tong lau
