Short Guide : Maintaining Your Historic Building

THE HONG KONG INSTITUTE OF
SURVEYORS

Funded by Built Heritage Conservation Fund, Development Bureau

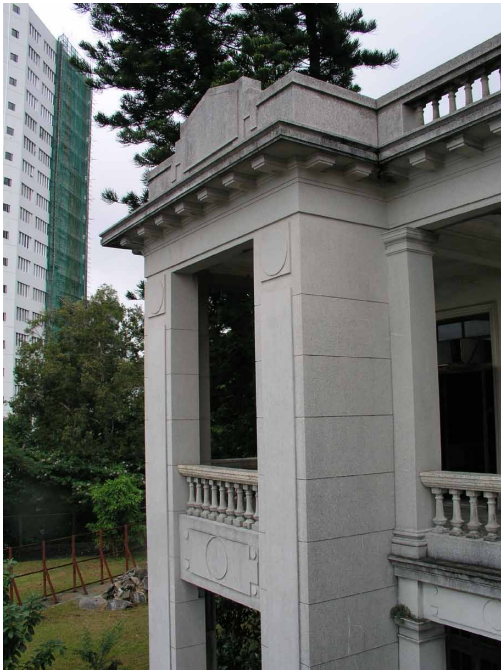
One of modern Hong Kong's ubiquitous exterior building finishes is Shanghai plaster. This decorative feature could be considered as part of the same family as granolithic and possibly also terrazzo. All three are variations of the same basic recipe of cement, sand and fine stone aggregate. All are protective and durable whilst at the same time used as decorative coatings. It is commonly found in the Western-style buildings in Shanghai and Southeast Asia in the 20th century.

The Shanghai plaster wall finish

Granolithic finishing materials such as Shanghai plaster or terrazzo are more durable than paint as they are cement materials. Hairline cracks may be developed due to thermal movement. Staining and building up dirt on the surface over time is one of the major concerns for these finishes. Before

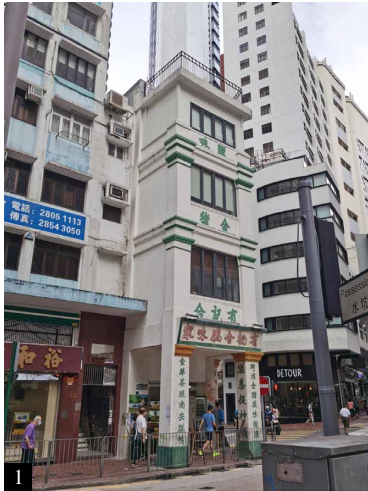
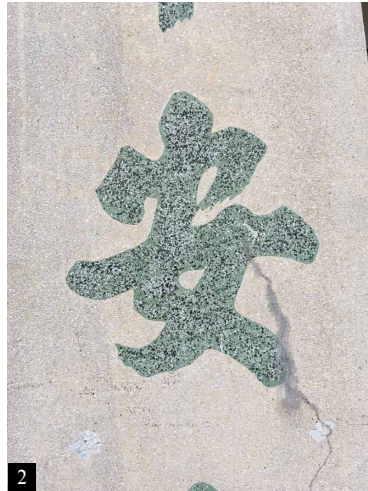
Terrazzo is used to create a smooth surface by grinding and polishing the granolithic render to give an appearance similar to that of polished marble. The history of terrazzo dates back to over 500 years. Terrazzo (Italian for Terrace) floors were invented in Venice during the 15th century. Workers were left with oddly shaped pieces of marble after jobs. They would put the small marble rocks in clay and grind them flat for a more comfortable walking surface.

1. Terrazzo sign and columns of 1 Queen's Road West, Sheung Wan
2. The detail of terrazzo

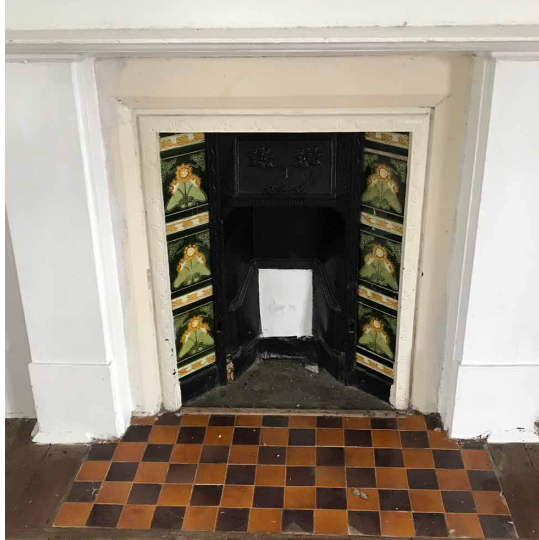
Ceramic is created with white, red or brown clay that is combined with sand, lime, kaolin, feldspar and other ingredients depending on the materials and performance required. Historically, glazed ceramic tiles were used for walls and occasionally incorporated into fireplaces, furniture and other items. Glazed ceramic tiles can withstand normal wear and tear well and are washable. Therefore, they are relatively easy to maintain. Being relatively straightforward to produce, durable and simple to clean, ceramic tiles were widely used in bathrooms and kitchens. As buildings became larger in Hong Kong for both public and residential occupancy, tiles also became a popular choice for stairwells and public spaces, such as hallways.

The incorporation of glazed ceramic tiles in fireplace

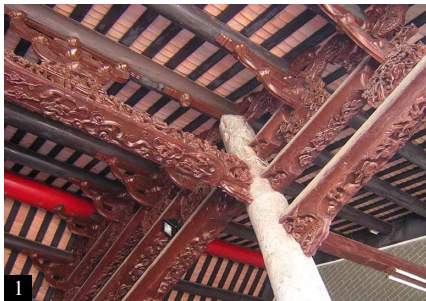
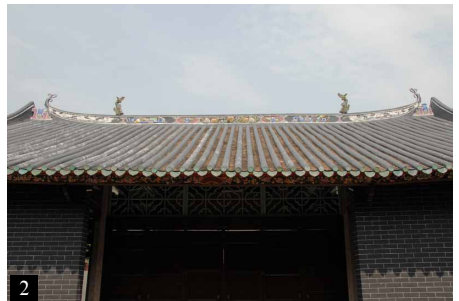
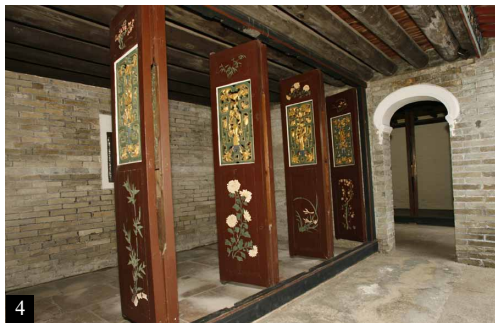
Built-in wood structure, most of the pillars, purlins, tie beams and bucket arches were completely exposed so that people can clearly see, which also give the craftsmen an opportunity for art processing. As an essential part of Chinese architecture, it embodies people's plea to heaven and is an important testament to the 'unity of heaven and man'. Consequently, the decoration of the roof is in no way inferior

1. A richly timber crafted beam and strut system of Tang Ancestral Hall at Yuen Long
2. Plaster decorative ridge of Tang Chung Ling Ancestral Hall at Fanling
3. Plaster decorated wall frieze and a fish water spout of a roof gutter
4. Carved timber door of the side chamber of Tai Fu Tai Mansion at San Tin

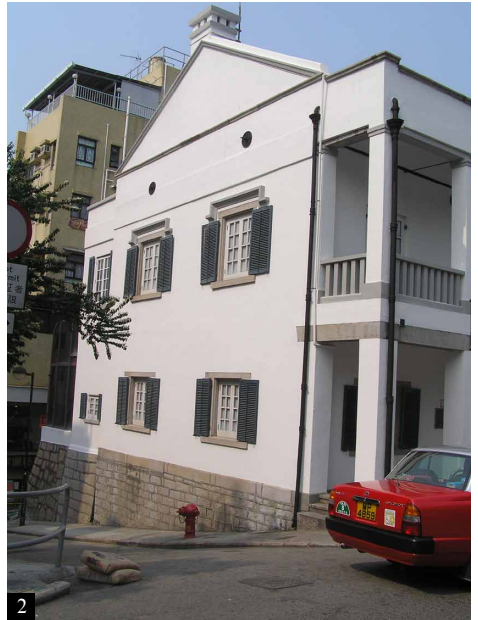
And to add a sense of solemnity, columns became the main architectural language, with decorative treatments on the top and bases of the Roman arch. The top gable is often decorated with triangular gables to reduce the dullness of the roof level. The pitched roofs reflect an adaptation to the subtropical climatic conditions in Hong Kong.

1. Old Stanley Police Station at Stanley
2. Triangular gables of Old Stanley Police Station

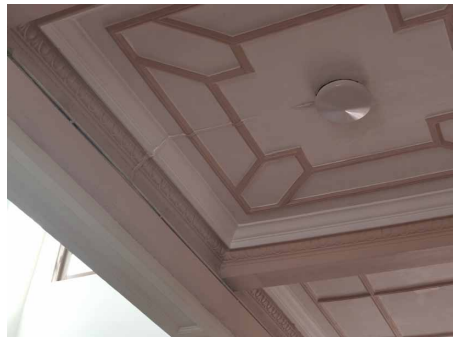
Ceilings in Western colonial architecture were normally built with substantial wooden joists with plaster applied to laths or, in more modern buildings, plasterboard nailed to the joists. In houses built before 1939, ceilings were usually constructed from laths, i.e. thin wooden slats which were nailed to the joists, coated with plaster that oozed between the laths and which, once became dry, locked the plaster to the laths. Distemper can be one of the various types of decorative finish, and it can be used both on the wall and ceiling. Distemper and water paint fell out of use by the 1950s with the advent of acrylic (latex) paints.

Distemper ceiling of the Main Building, the University of Hong Kong.

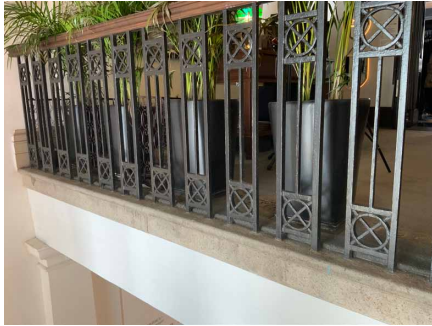
The largest and most conspicuous elements of decorative metalwork in historic interiors are staircase balustrades and balusters. Wrought ironwork is composed of bars of iron, heated and hammered into scrolling shapes that can be welded together to form balustrades, gates and screens of almost any size. The shape, material and size of balustrades are varied, while the balusters are fixed by the longitudinal ornaments, which are the link between the two columns, using the distance formed by the columns to give the building façade a sense of rhythmic beauty.

The iron staircase baluster of Tai Kwun, Central

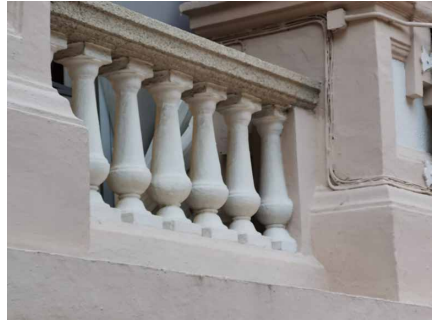
The baluster of the Main Building, the University of Hong Kong.

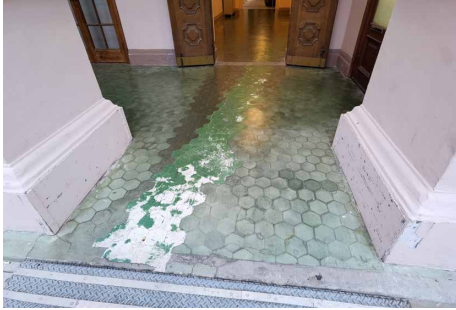
Ageing and wear of floor tiles

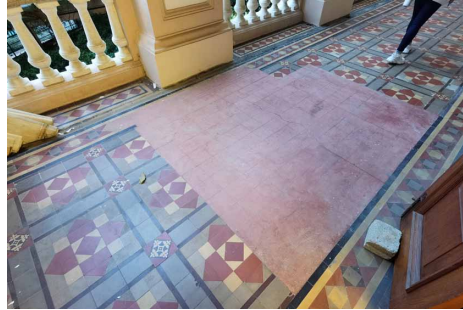
Damaged tiles were replaced by improper tiles

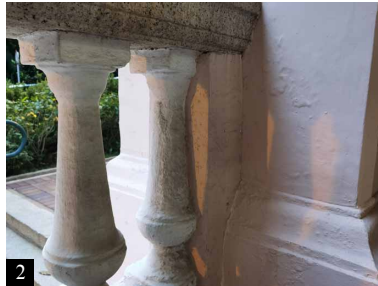
or inadequate maintenance are other common causes. Water seepage, rising damp from the ground, and biotic attack and salt crystallization are problems that commonly affect the substrate, leading to issues such as poor adhesion, chemical degradation, efflorescence and volumetric expansion of the paint or coating material.

1. Peeling of the painting on the wall
2. Efflorescence and volumetric expansion of the paint.

Life span of paint coatings is limited and it is recommended to consider redecoration according to manufacturer's recommendation. A proper maintenance regime should include periodic cleaning and touch-up and periodic inspection so as to extend its lifespan.

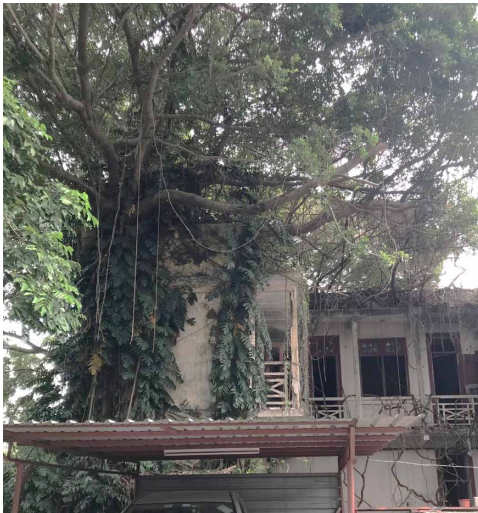
The Chinese Banyan growing on the vertical surface of a building

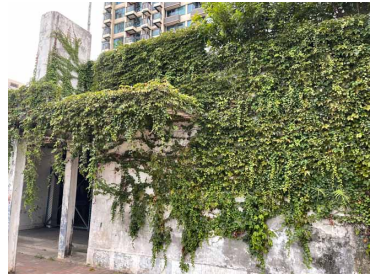
Climbing plants grow up high for sunlight and over buildings by attaching themselves to the nearby walls through a variety of structures, such as tendrils, adhesive discs, thorns and adventitious roots. For example, diverse-leaved creeper (*Parthenocissus dalzielii*) has tendrils tipped with adhesive discs that can affix to walls. Night-blooming cereus (*Hylocereus undatus*) and creeping fig (*Ficus pumila*) use adventitious roots to attach themselves to walls. Thousands of these attachments and penetrations can result in damage to the built structures. They can drain moisture from the walls and dislodge masonry, also damage the mortar on pointed brickwork, prise the mortar away on the rendered surfaces, allow water to encroach and cause further damage.

Climbing plants including diverse-leaved creeper and creeping fig growing on the vertical surface of a building

On pointed brickwork, climbing plants with attaching structure can result in damage to the mortar, while on rendered surfaces, the plant can actually prise the mortar away from the wall, allow water to encroach and cause further damage.

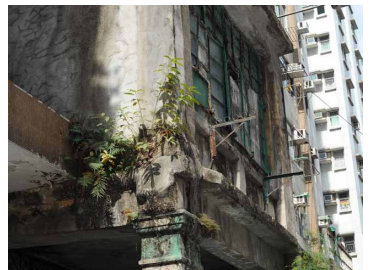
Although mosses and weeds are small in size, they can also become a problem on buildings by erosion. Not only the roots allow water to encroach into building materials, the natural acids excreted may then react with the alkaline materials used in construction, further weaken the tiles and bleach the colour. Together with the moss stains, it makes the buildings look old and unattractive. Besides, these small plants provide cover for fungus, which is much more destructive to the wooden materials.

Fern and small trees growing on the vertical surface of the building. Moss stains can also be found.

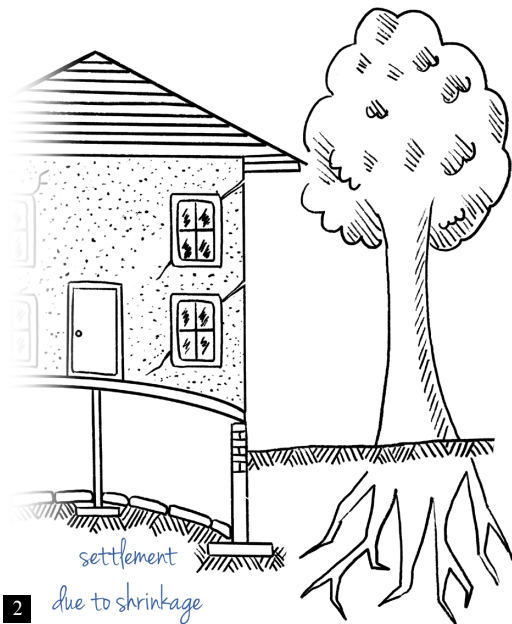
2. Tree roots can dry out the soil and cause differential settlement to building

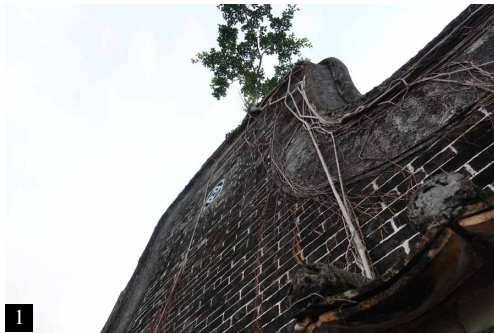
Plant roots may result in cracks or enlarge cracks which can retain water and allow small animals to penetrate in. Plants also retain moisture and cause chemical deterioration of building materials. Further, substantial growth of plants may hide the problems of the building materials underneath.

1. The plant root penetrates to the mortar of the brick wall

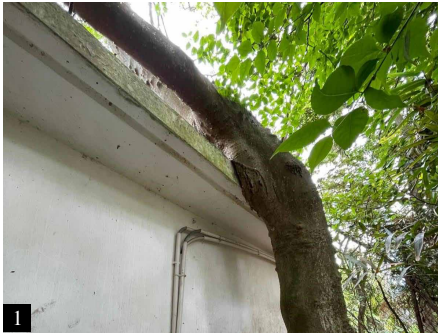
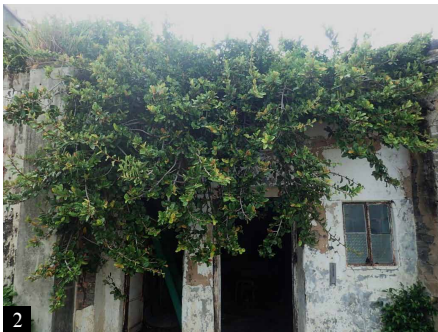
Large tree limbs and branches hanging over the rooftop could become dangerous during the storm, and it could cause serious damage to buildings when branches or limbs fail. Also, damage to roofs may occur if tree branches rub the roof over time.

1. A tree branch rubbing and hanging over the roof
2. Plants growing over the roof
3. The plant roots penetrate the roof of the building.

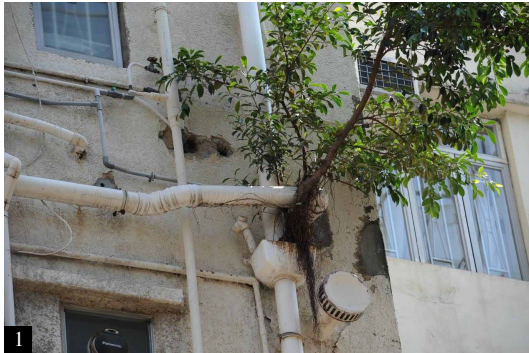
1. A banyan tree growing from the gutter and in the rainwater hopper
2. Old Stanley Police Office at Stanley
